# UNDERWATER BRIDGE INSPECTION REPORT

STRUCTURE NO. 73514

SAINT GERMAIN STREET (MSAS NO. 128)

MISSISSIPPI RIVER

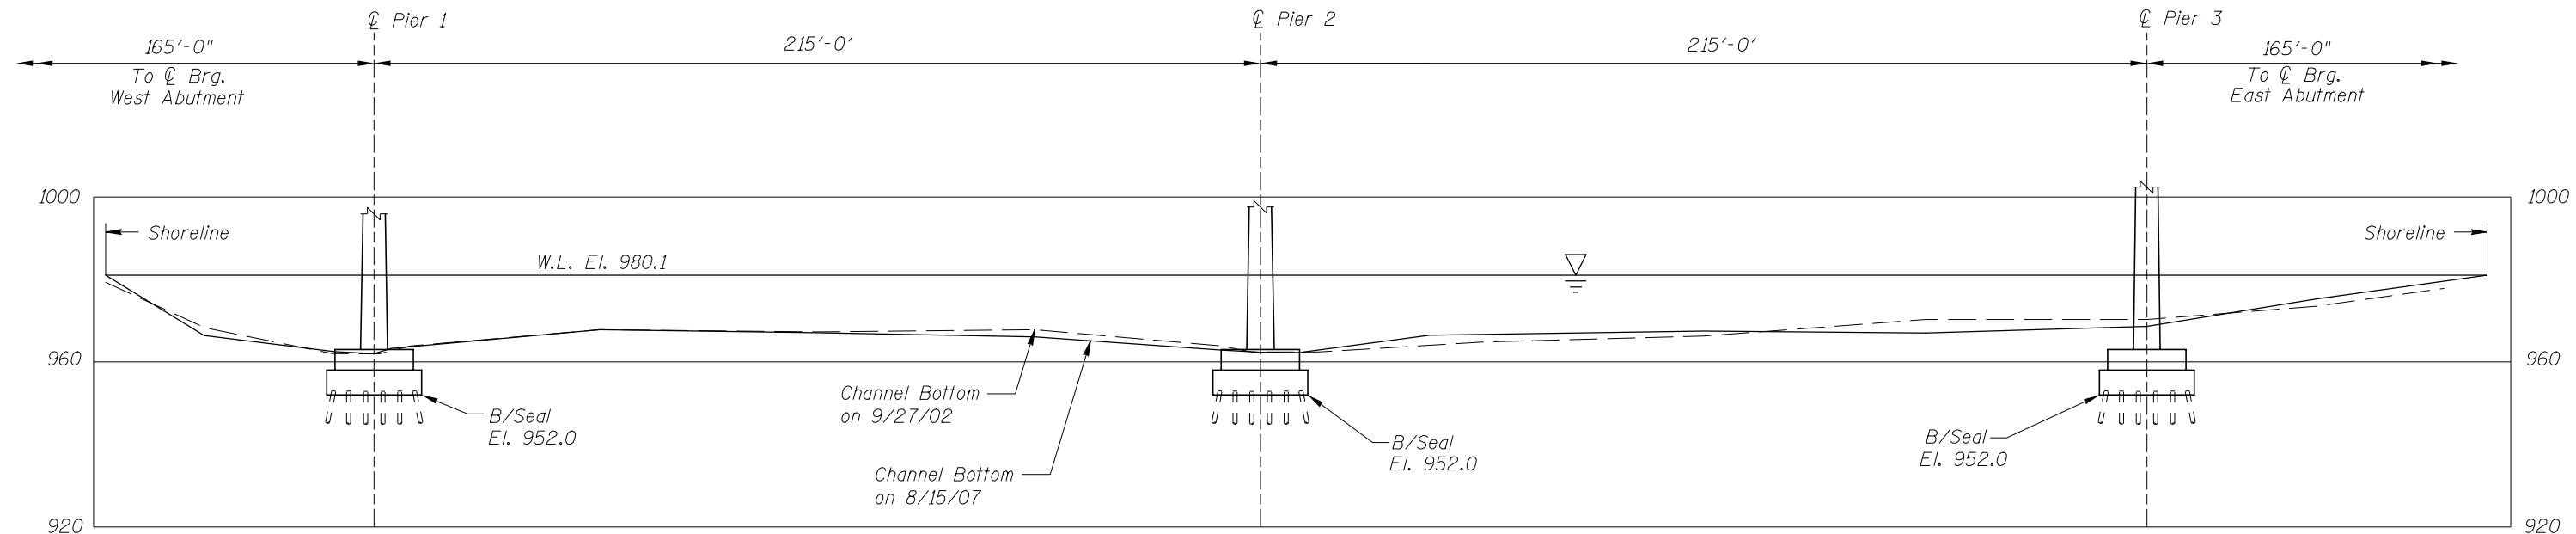
UPSTREAM FASCIA PROFILE

- 3 Light scaling with a maximum penetration of 1/8 inch and areas of impact damage with penetration up to 1/2 inch were observed on all piers from 3 feet above to 1 foot below the waterline.

- 6 A line of 3 steel I-beams was observed extending through all of the piers and cut flush with the pier shaft faces at 5 feet and 11 feet below the waterline. The concrete surrounding the I-beam was smooth with no deficiencies.
